KOOTENTAI DEVELOPMENT IMPOUNDMENT DAM
TOE DRAIN INSPECTION II REPORT

July 27, 2010

BHI File No.: R.56.6

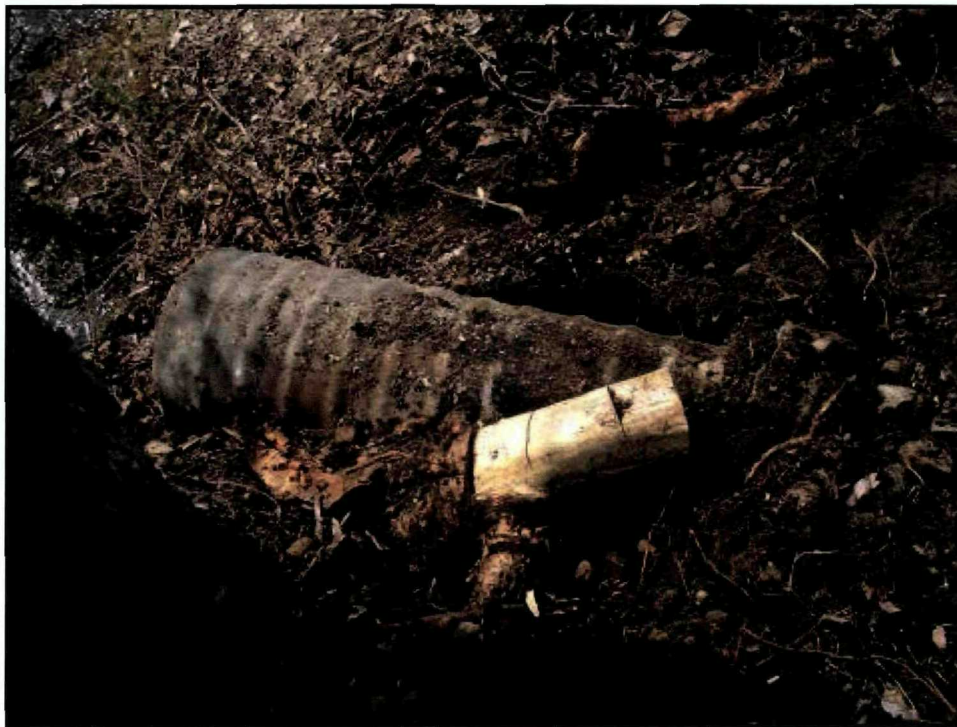
FIGURE 1: OUTLET OF DRAIN 7 AT COTTONWOOD TREE

The first project carried out was the removal of the end of drain 7. It was determined that the cottonwood tree that was growing adjacent to the end of the pipe (to the left looking downstream) had completely engulfed the end of the drain with thick roots. A photograph of the roots near the outlet is shown in Figure 1 below.

The tree roots had completely filled the interior of the drain for the full 20 ft. and an additional 5 ft. of the roots were removed from the pipe into the embankment. Not all of the roots and debris could be

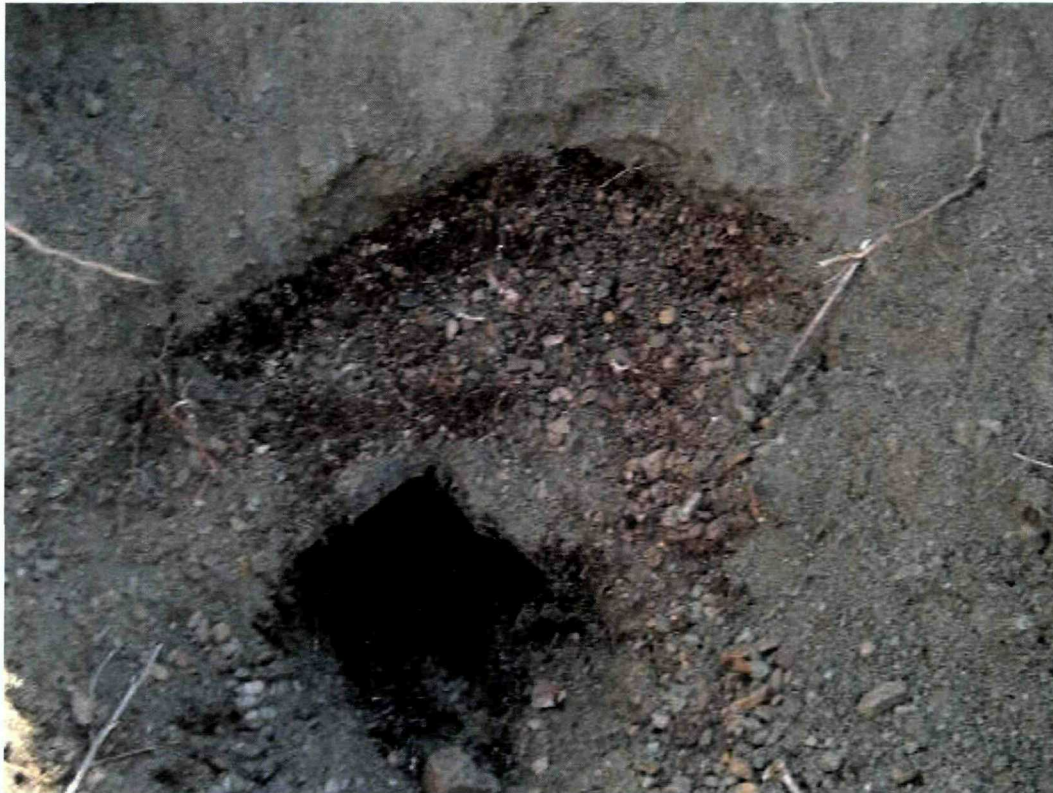
FIGURE 2: DRAIN ROCK AROUND DRAIN 7

removed from the pipe and we could not reestablish flow into the pipe. The excavation was terminated at 20 ft. as the depth of overburden on the embankment side was unsafe and no further excavation could be conducted without shoring or radical fill removal. It was interesting to find that the drain had been placed in a $\frac{3}{4}$ -inch round gravel collar that extended 12-inches all around the pipe. A photograph of the drain rock collar around the pipe is shown in Figure 2 below;

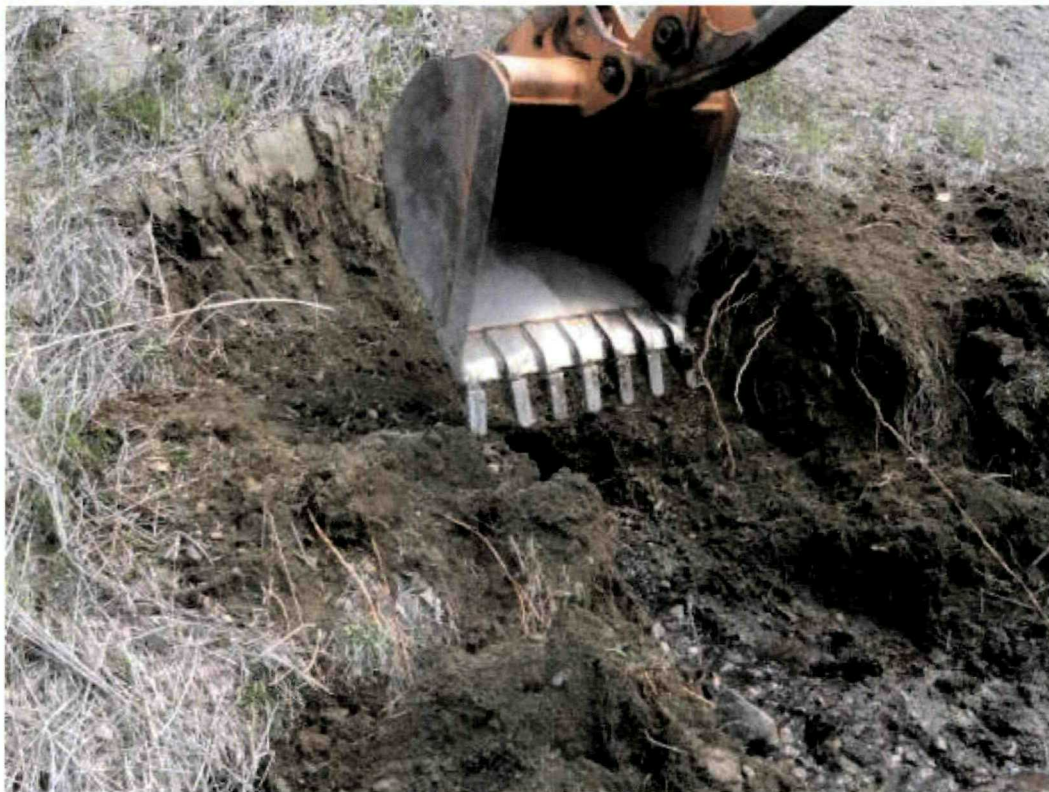
FIGURE 5: DRAIN 3 OUTLET

The repair to outlet of drain 3 was the second project completed. The Case 580 was used to excavate and remove the last five (5) feet of the outlet. It was determined that there is not a concrete headwall at the end of the pipe but is rather compacted earth and roots that are vertical above the pipe. It appears that the lower pipe was not well connected to the upper pipe and somehow, assumed to be from frost expansion, rose in a level plane, leaving a vertical wall of dirt and roots above the up stream pipe. Once the excavation was cleared it was determined that there is a collar of drain rock around this drain as well. It is noted that the drain rock was larger and more angular than the rock around drain 7. A photograph of the outlet end of drain 3 just as the backhoe is excavating the last section of pipe and showing the water as it is starting to drain from the outlet is shown in Figure 5 below.

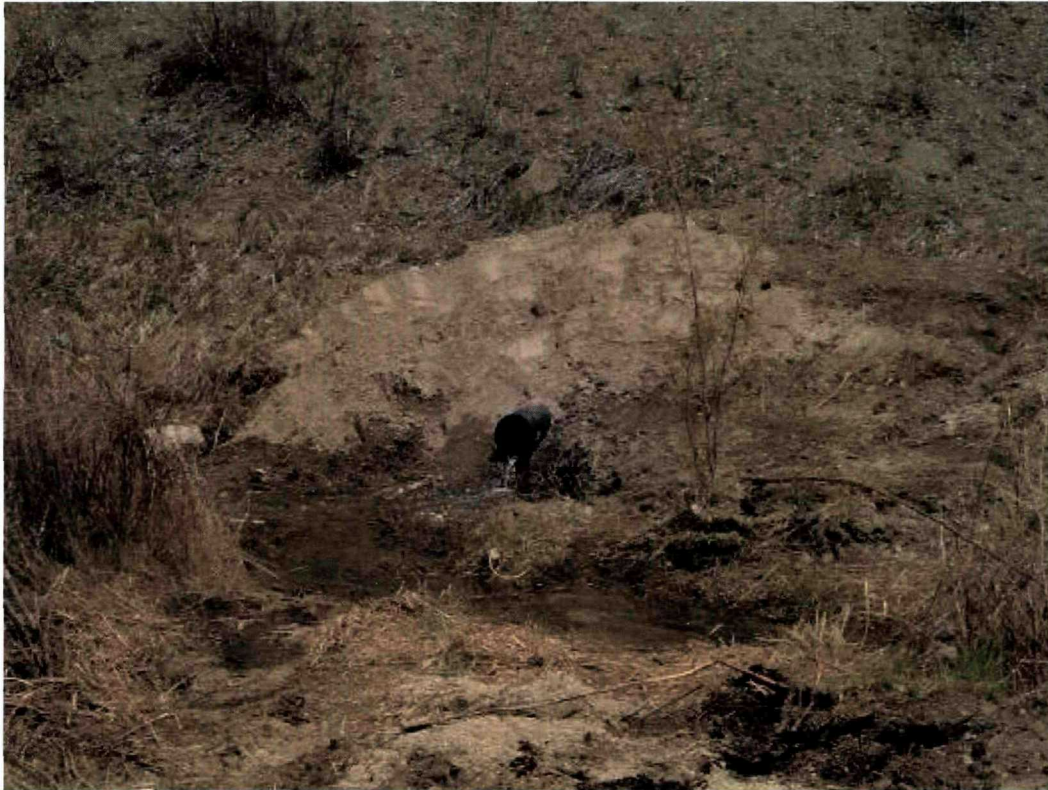
FIGURE 6: DRAIN 3 AS FINISHED

When the end was removed, water with some silt, some sand and a black colored water, assumed to be organic deposits, flowed out of the pipe for several minutes. Once the pipe was clear, the video camera was used to inspect the interior of the pipe. Once the camera inspection was completed, a base of $\frac{3}{4}$ " minus, crushed aggregate was compacted up to the invert of the existing pipe, a new outlet was placed on the compacted fill, and then covered with more $\frac{3}{4}$ - inch minus and compacted until completed to grade. The grade around the outlet was shaped to match the existing slope, top soil was spread and the area was seeded with a native riparian seed mix. A photograph of the outlet as finished is shown in Figure 6 below.

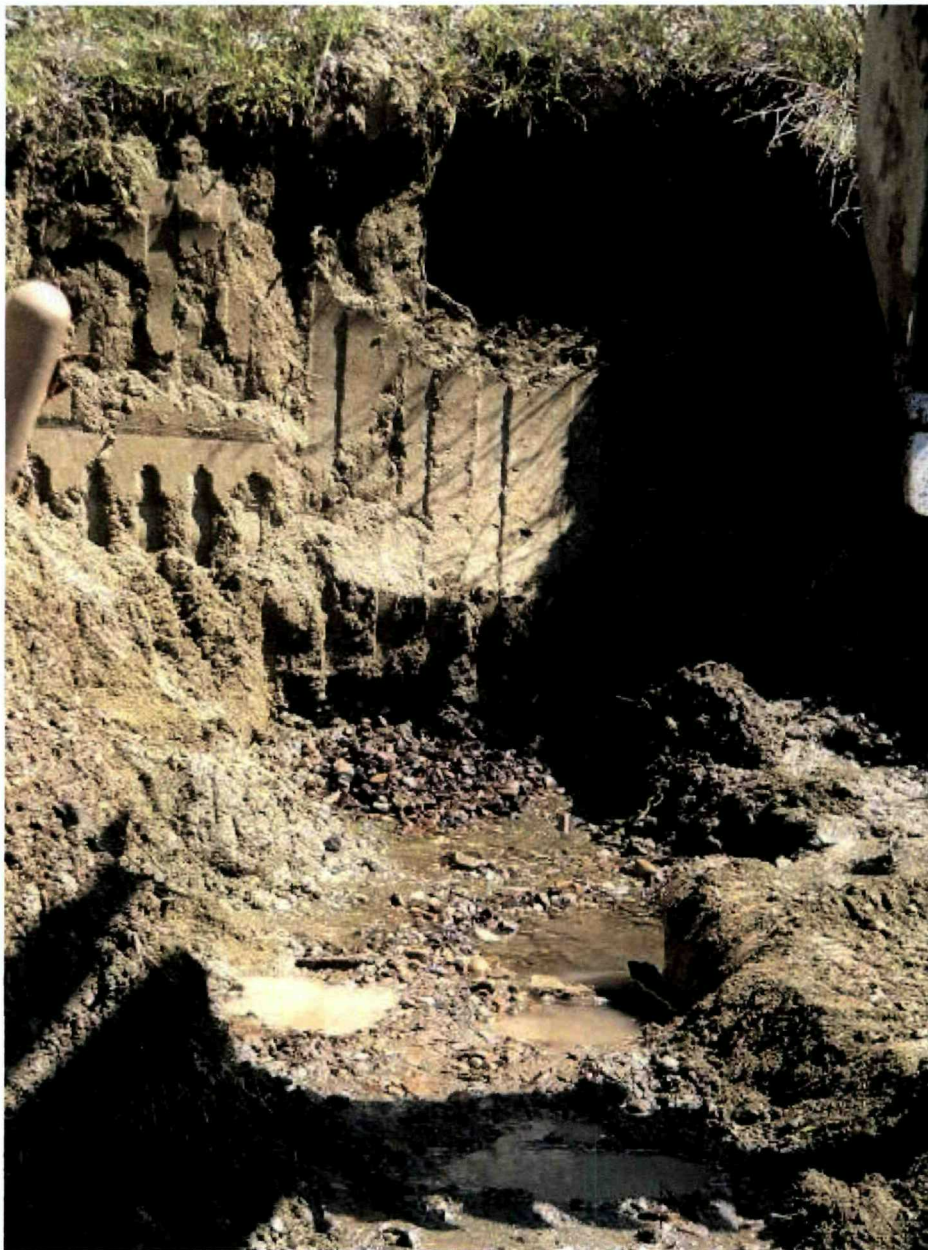
FIGURE 7: TERMINAL END OF DRAIN 11 AND DRAIN 10

The third project was to remove the outlet end from drain 11, excavate the void space and explore the embankment at the end of the drain. The 580 Case was used to remove 3 sections of concrete pipe which was a total of approximately 15 ft. The void space collapsed as soon as it was exposed. Excavation at the end of the drain revealed the same condition as was found at drain 3 and drain 7; the pipe is encased in a gravel collar. It was unusual to find that the end of drain 10 was also located in the same gravel matrix and also terminated at the same location as drain 11. It was also interesting to note that the gravel around drain 10 and drain 11 is a 1 ½ -inch to ¾ -inch round rock. A photograph of the gravel at the end of drain 11 and the terminal end of drain 10 is shown in Figure 7 below.

There was a large piece of an intact concrete pipe found at the end of drain 11 and pieces of broken pipe and gravel near drain 10. Some exploration was made into the embankment to either side but no other section of drain pipe was found, no other signs of gravel or drain rock was located and no other material, other than the embankment material, was near or around the pipe or gravel collar. The invert of the gravel collar was cleaned to the same inert elevation as the existing pipe and a new 15 ft., 8-inch pipe was placed in the gravel collar. Approximately 10 ft. from the end of the excavation, a large amount of water was found to be flowing in the gravel matrix below the invert of the old pipe. Therefore the invert was excavated deeper and 6 ft. of 12-inch HDPE pipe was placed on the end of the 8-inch pipe with the intent of collecting flow from the gravel as well as from the inside of the pipe. The

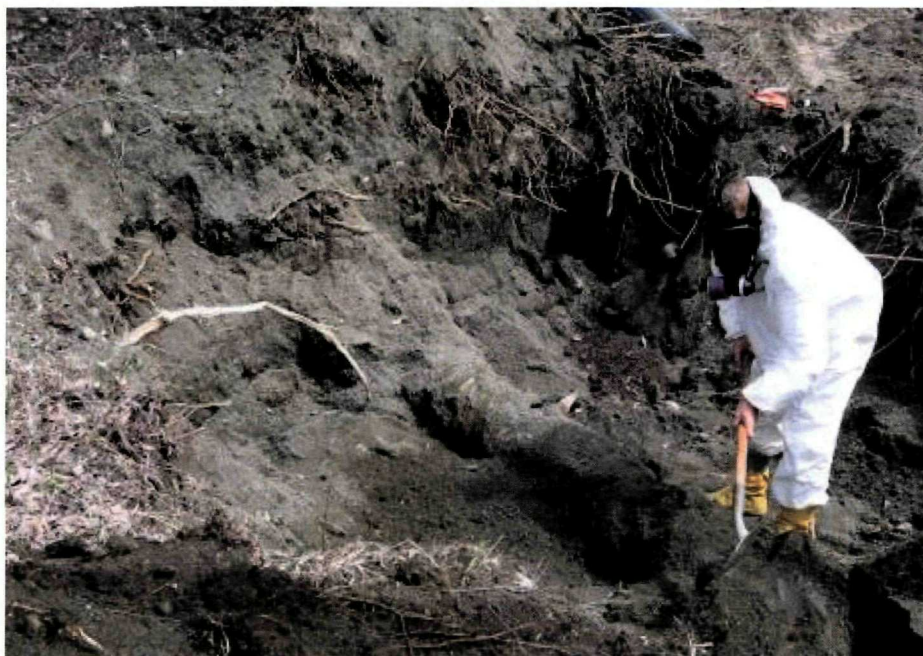
FIGURE 9: DRAIN 2 NEAR ELBOW

The fourth repair project was to excavate drain 2 near the area where the pipe bends 22° toward the embankment and a break in the pipe was noted in the previous video investigation. The area at the break was excavated and it was discovered that it is an elbow that was field constructed from pieces of corrugated metal that also reduces the main drain from an 18-inch CMP into a 12-inch CMP. Over the years the water must have worked its way out of the pipe at the elbow and gravel and dirt deposited inside the pipe at the gaps in the elbow. The pipe coming out of the embankment, an 18-inch CMP, was in poor to very poor condition. The metal in the pipe was thin and there was rust corrosion on the inside and outside of the pipe. A photograph of the pipe near the elbow is shown in Figure 9 below.

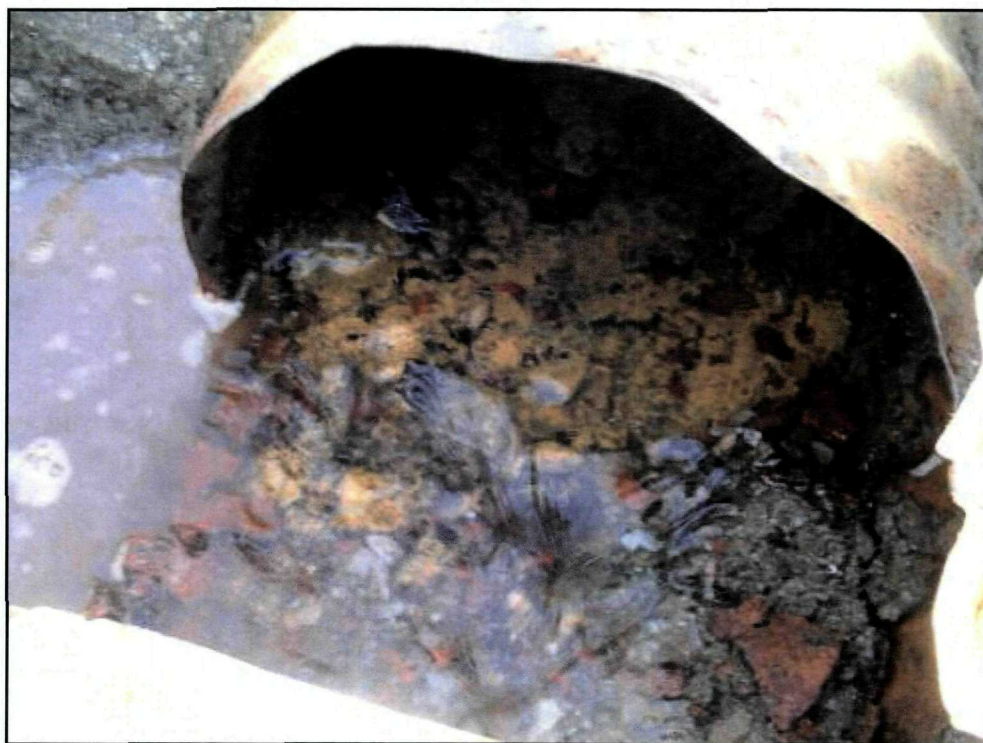
FIGURE 10: DRAIN 2 AT CUT

We carefully cut and removed the end of the pipe at the toe of the embankment. A photograph of the end of the pipe at the cut is shown in Figure 10 below.

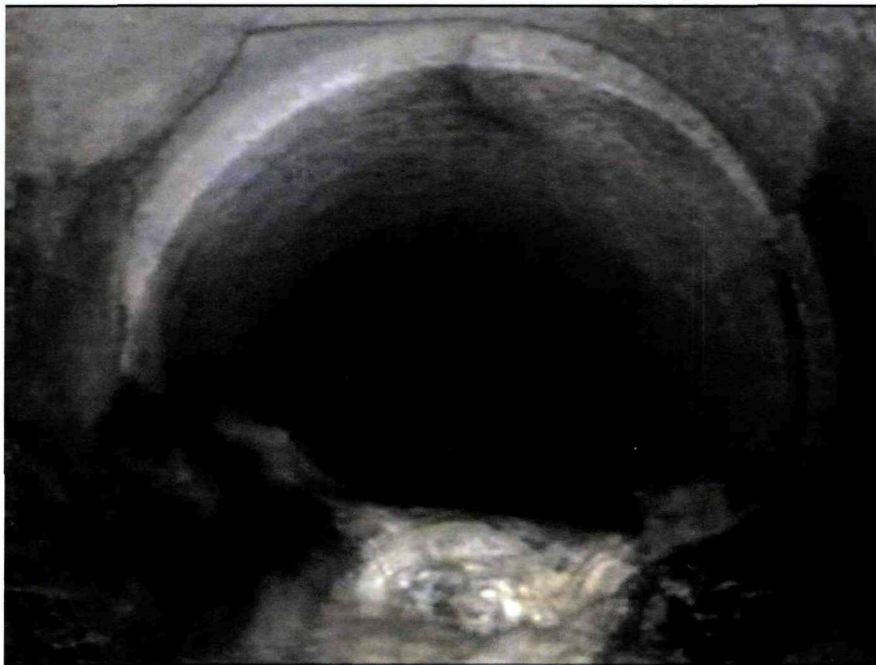
FIGURE 14: BROKEN CONCRETE PIPE IN DRAIN 3 AT 137 FT.

The camera then travels through approximately 80 ft. of open sections of pipe and at approximately 137 ft. the camera encounters a broken section of pipe and a change in invert elevations where water can be seen pouring over a lip of sediment. A still photograph from the video is shown in Figure 14 below.

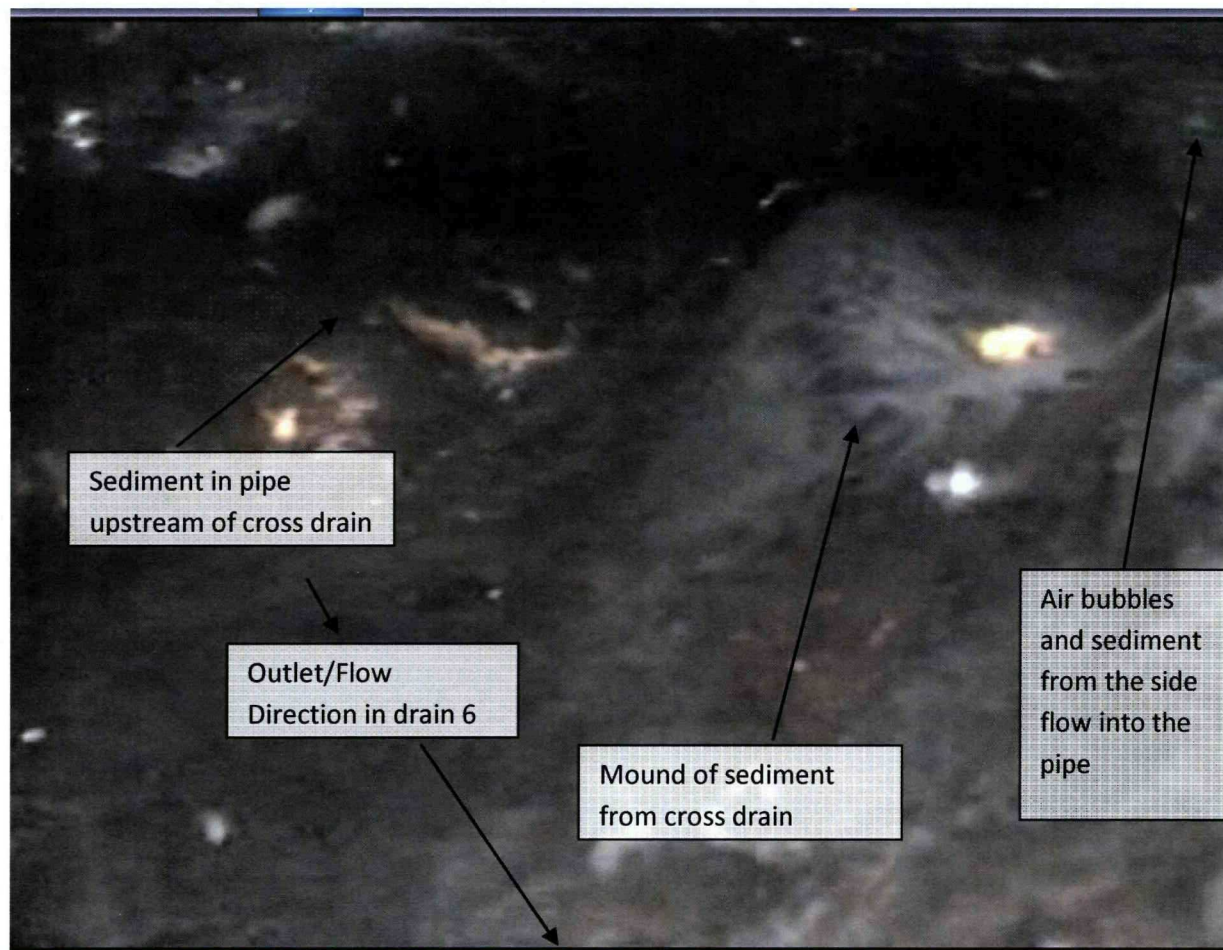
FIGURE 17: DRAIN 6 AT 342 FT.

After review of the video it was found that at approximately 320 ft. the sediments on the bottom of the pipe start to increase and was the cause of the sediment discharge increase from the end of the pipe. At 342 ft. there is a mound of sediment on the right side of the screen. Upon closer inspection air bubbles and sediment movement can be seen entering from the right and it is apparent that this is the location where the cross drain must enter the main drain. The still photograph from the video is shown in Figure 17 below.

The saddle shape on the right shown in Figure 17 is the mound of sediment from the cross drains and the white, smoke like traces in the top of the photograph, and in the video, are the air bubbles and sediment particles from the right side and from the upstream inflow mixing. Close inspection of the video shows the turbulence in this area that can only be from the side flow into the drain. We assume that as the two flows mix, the water becomes turbulent, losses energy, and drops the heavier particles of sediment in the invert of the pipe.

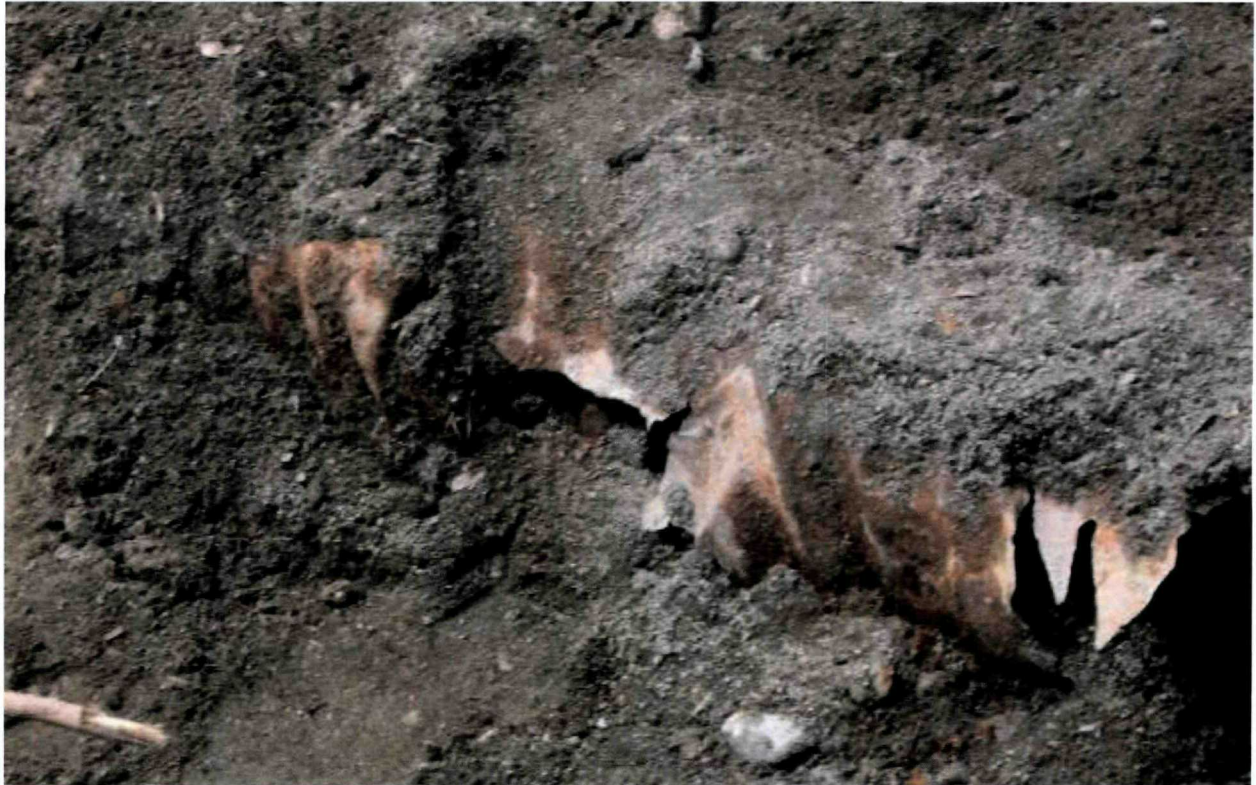
FIGURE 21: DRAIN 2 AT ELBOW

Break in drain 2. The break in drain 2 turned out to be poor construction of an elbow by the last contractor. This pipe is now in very poor condition having rust corrosion inside and out and the metal was very thin. We were able to cut the pipe with the tip of a hand shovel. A photograph of the pipe where it was cut is shown in Figure 21 below;

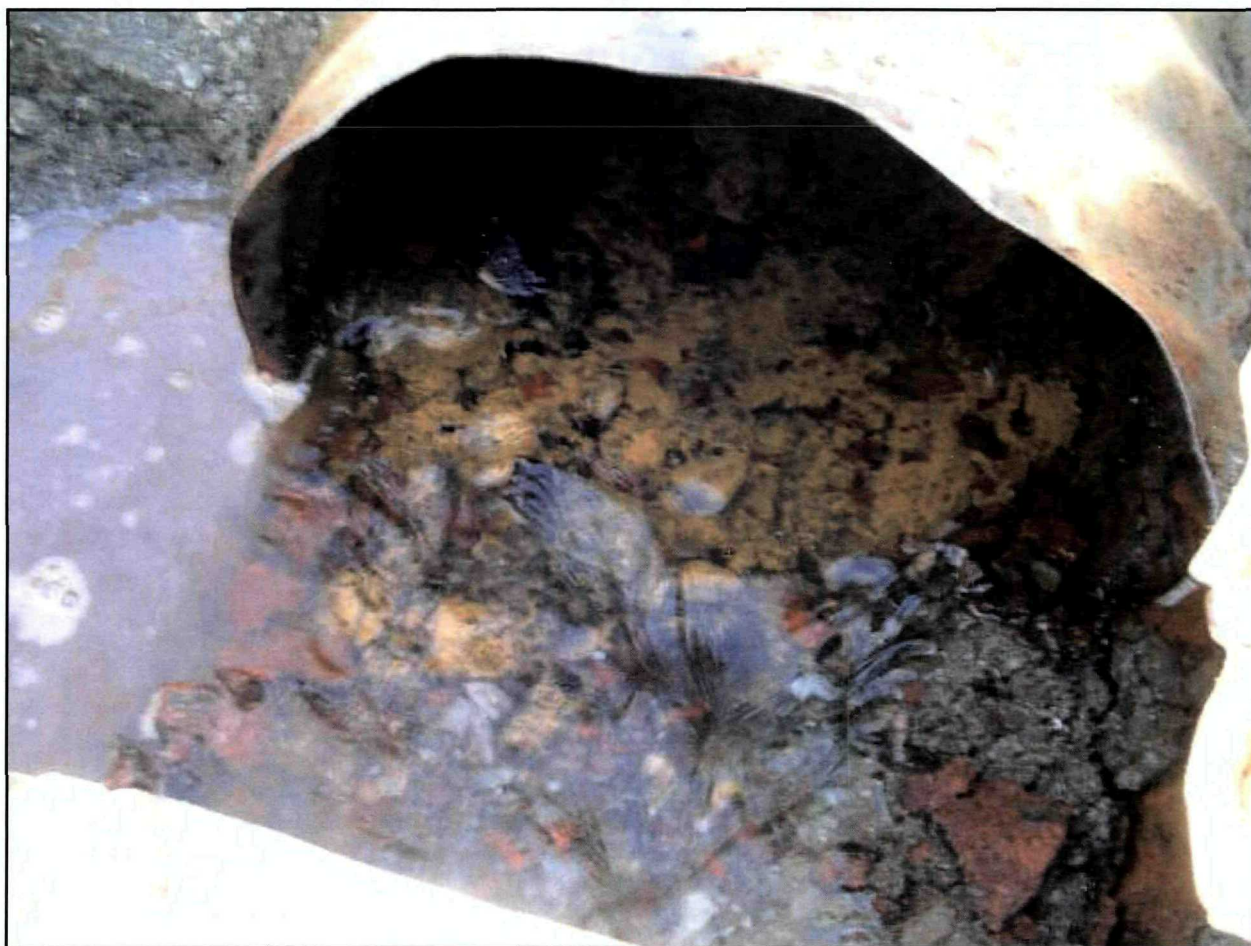
FIGURE 22: MATERIAL IN THE INVERT OF DRAIN 2

At the point of the collapse, we have estimated there is at least 12 ft. of overburden and excavation into the embankment. To find the break in the pipe is not possible without exhaustive shoring and excavation. Even if the break could be exposed, it is likely that it will be a concrete pipe that has collapsed further inside the embankment. The pipe was half filled with rocks, silt and sand with black organic silt in the matrix. A photograph of the material in the pipe after the pipe was cut open is shown in Figure 22 below.

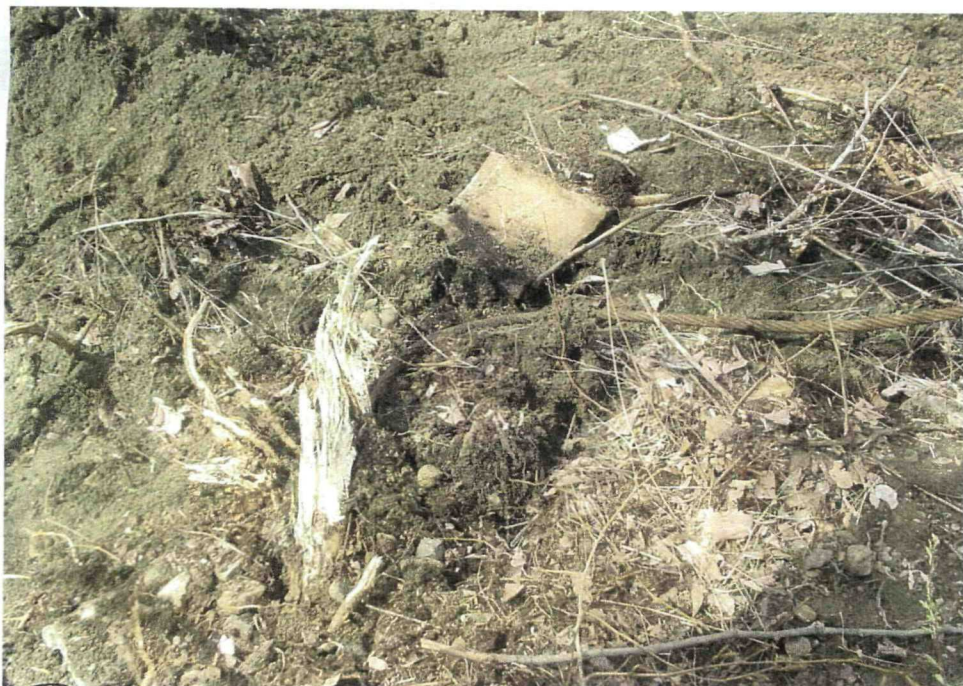
1. Roots and cable around drain 7

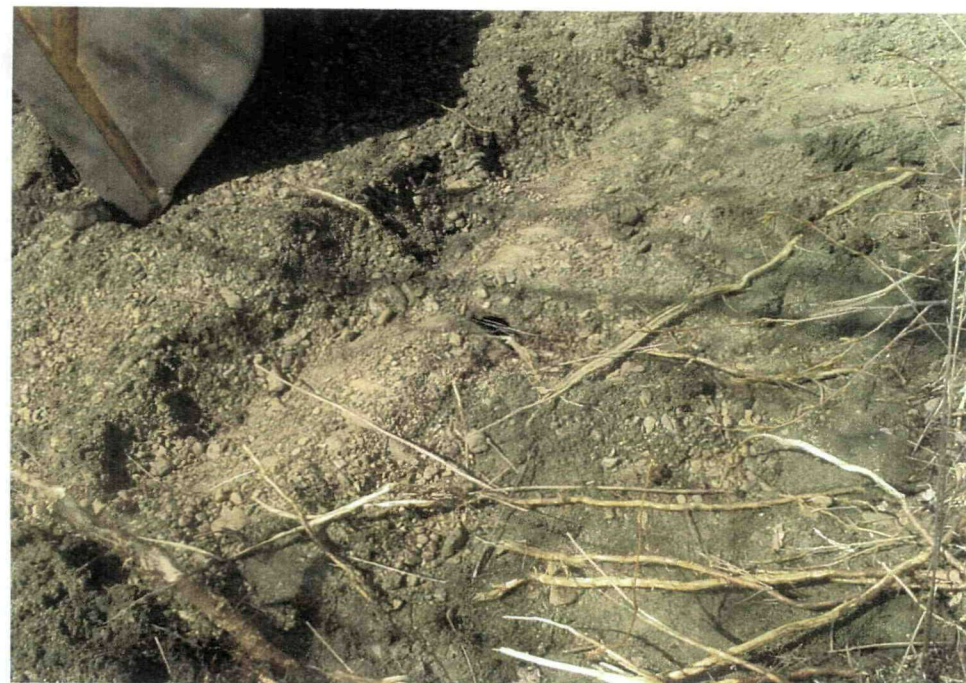
2. Top of pipe, drain 7

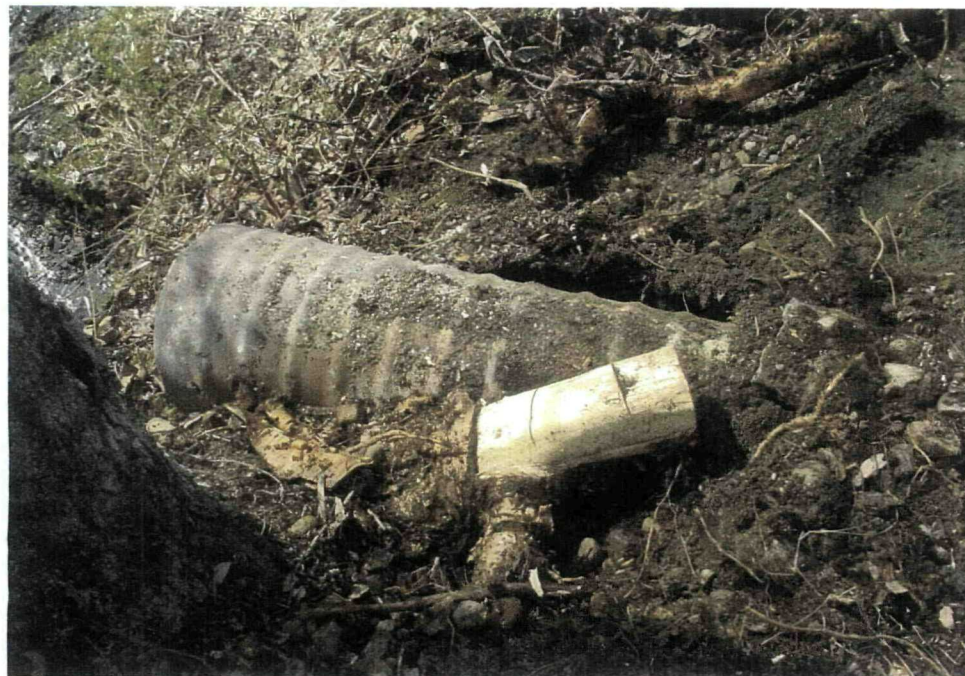
3. Root around drain 7

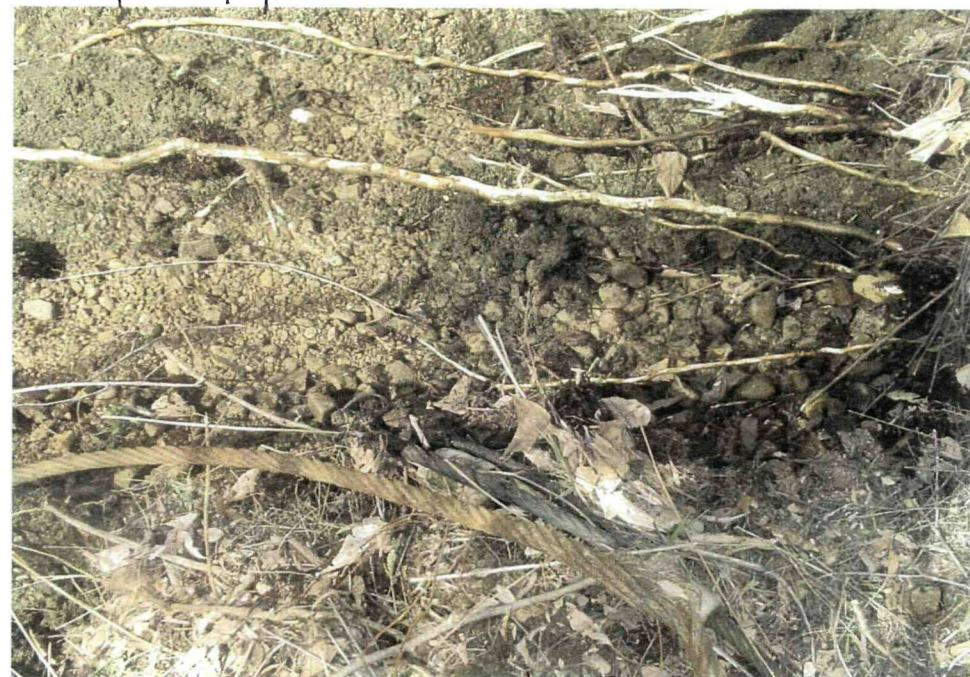
4. Gravel size on invert of drain 7

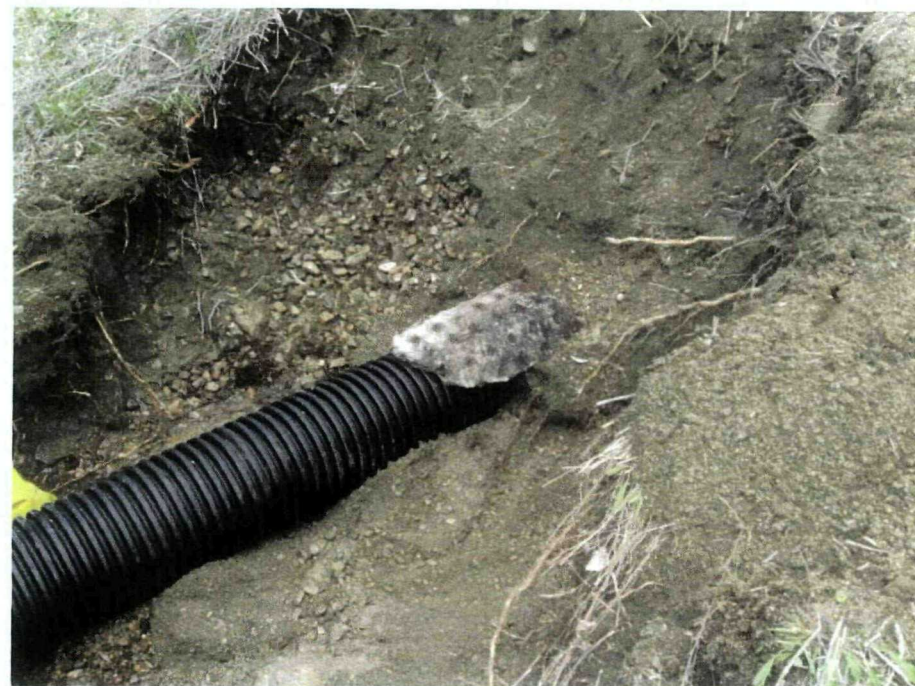
56. New outlet on drain 3 with broken concrete

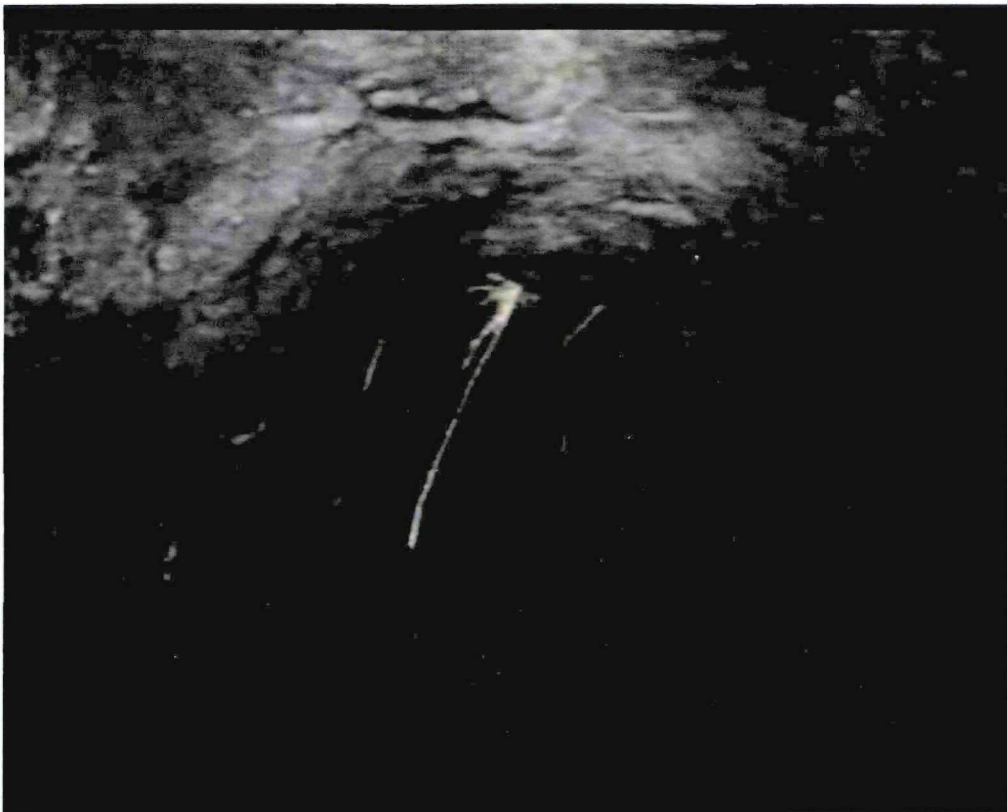
Drain 3: Transition into water at 32 ft.

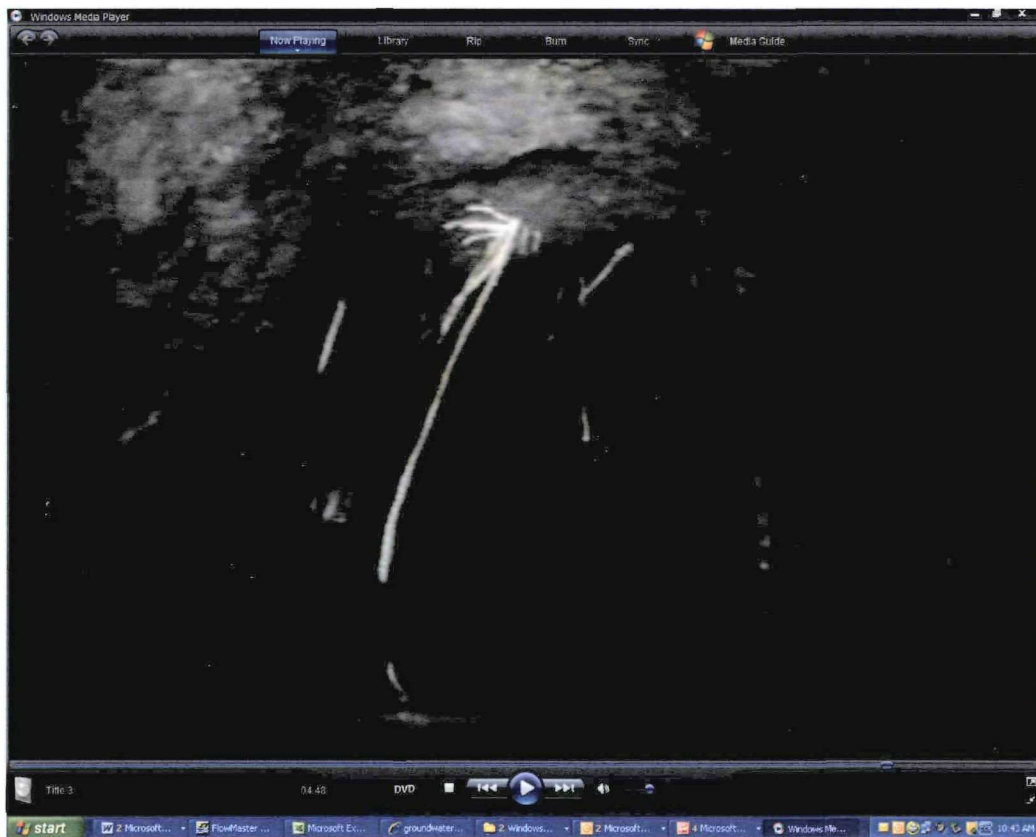
Drain 3, same as above

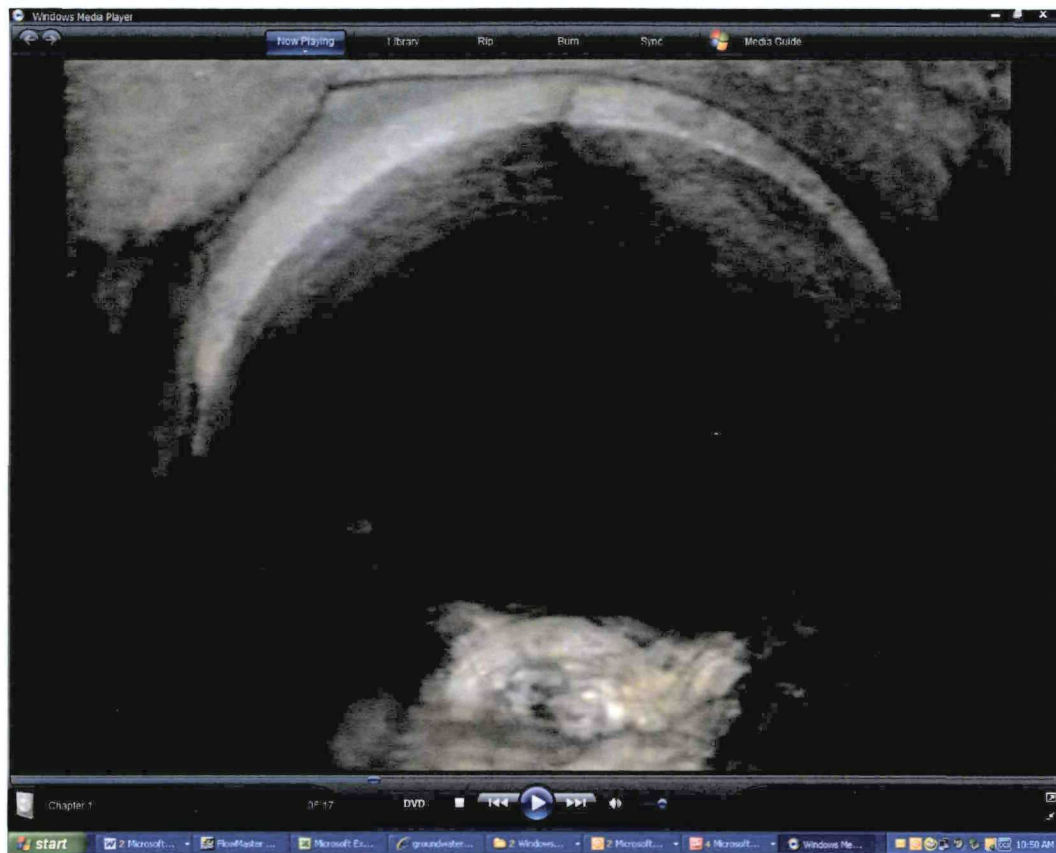
Drain 3 137 ft. from outlet

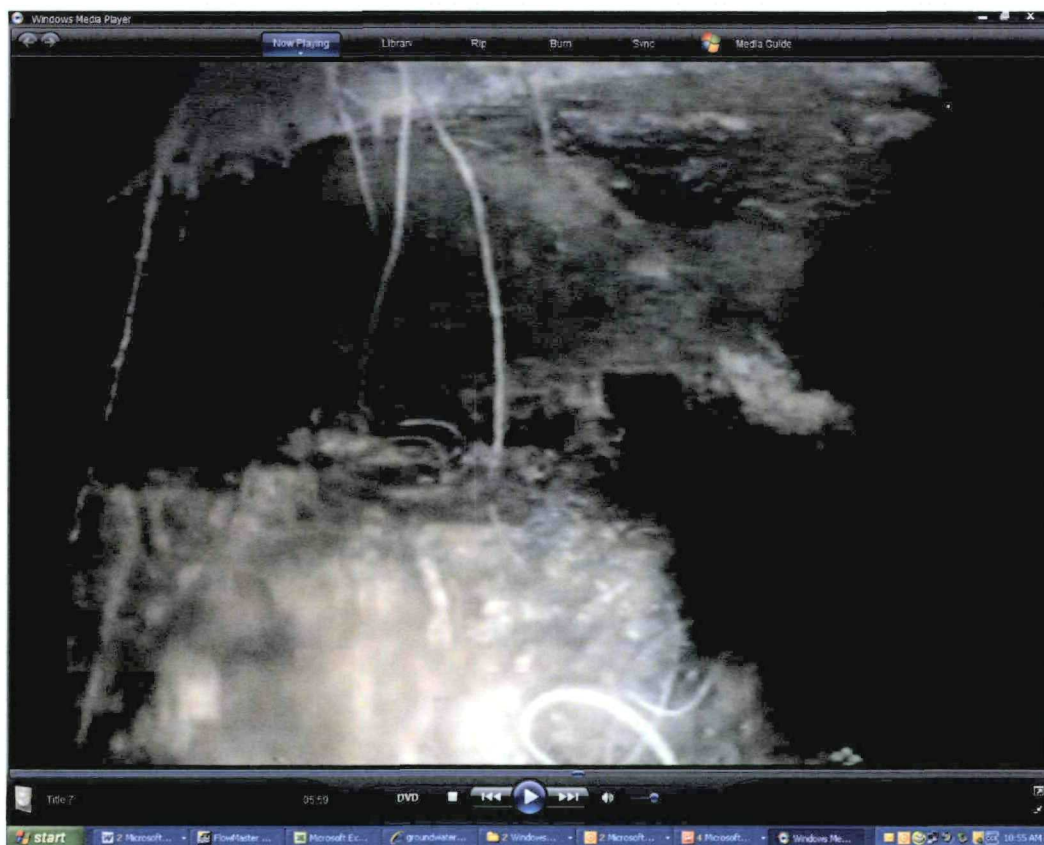
Terminal End of drain 2

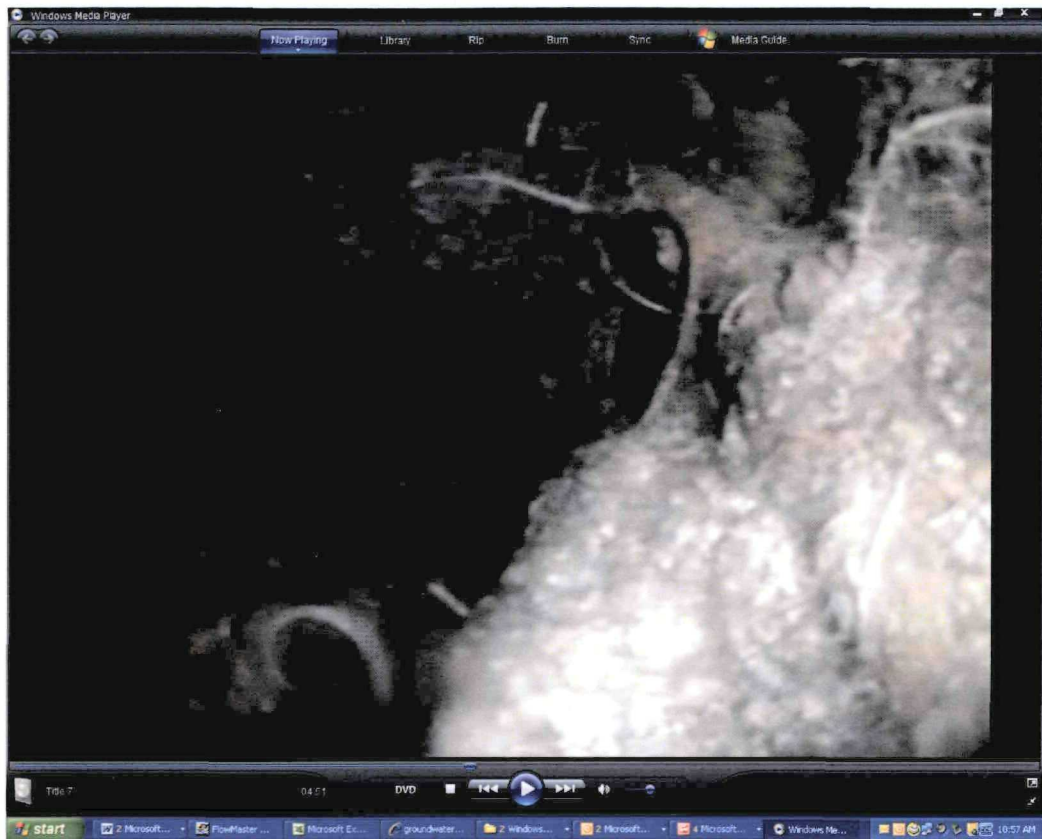
Broken concrete pipe, root and debris at the terminal end of drain 2.
